March 08, 2011

**Important Safety Notice**  
**For Appleton & O-Z/Gedney Products with SPLS Pilot Lights**

## Field Product Evaluation

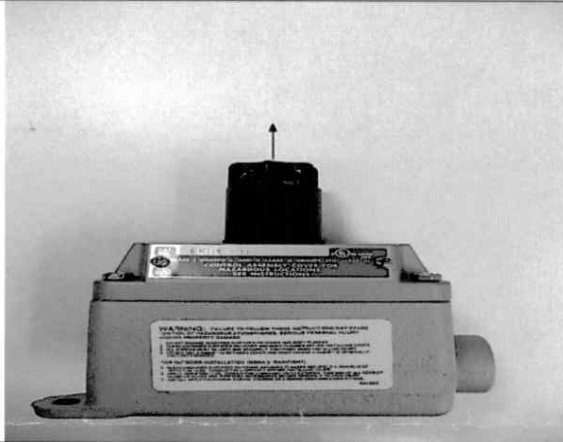
**Black Guard shouldn't come out loose**

For products with Pilot Light Assembled as shown, Firmly grasp the black Guard and pull away from the unit.

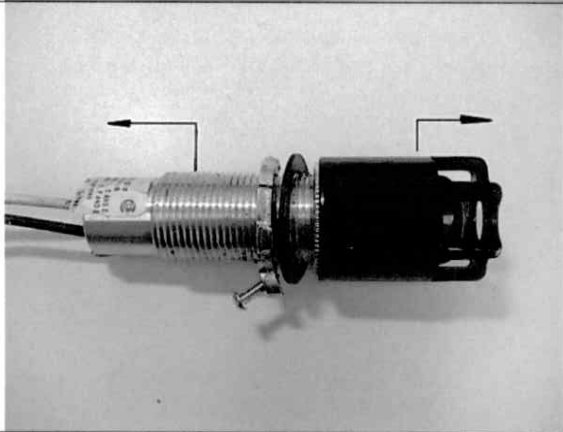
**Black Guard shouldn't come out loose**

For Pilot Light Assemblies,

Firmly Grasp The threaded portion of the assembly and the Black Guard and pull in the direction as shown.

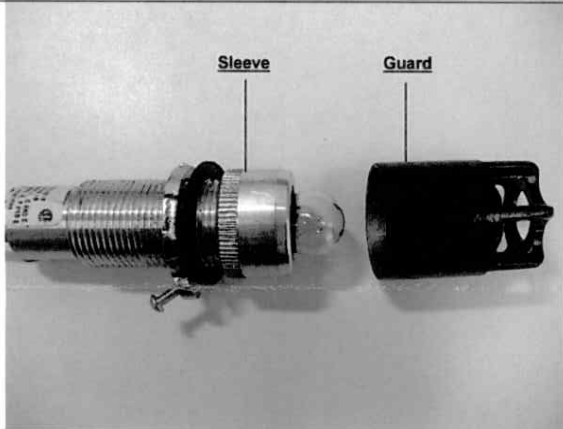
A potential safety issue has been identified with Appleton **SPLS Pilot Lights** whereby the Guard when pulled separates from the sleeve. This condition could cause equipment damage and /or serious personal injury.

**Black Guard and Sleeve Separated.  
Un-acceptable**

In the event product has been sold, please forward this notice and the attached inspection instructions to your customer. We will replace, at no charge, units exhibiting this condition.
