January 15, 2008

## Important Product Safety Bulletin

### Eaton/ Cutler-Hammer Brand Labeled Rotary and Toggle Disconnect Switches

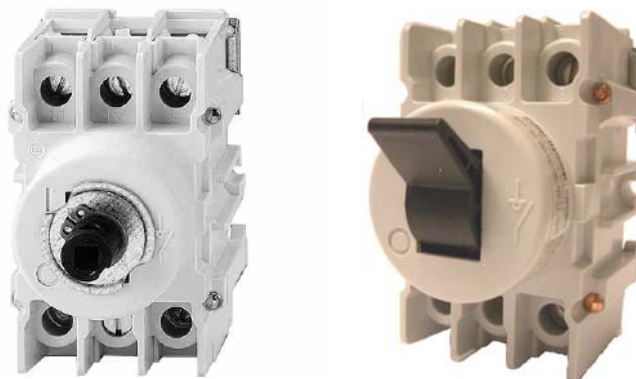
Affected Rotary and Toggle Disconnect Switches

The defect for the particular Rotary and Toggle disconnect switches supplied to Eaton and identified in Appendix A is directly related to a defect in a component contained within the switch. For some of the switches our supplier manufactured from Week 1 to 50 of 2007, a plastic plunger internal to the switch may fracture over time. If this happens, there is the potential that the plunger will no longer open one pole of the switch, leaving the pole energized when the switch is in the open position.

Subsequently, a user could move the disconnect handle of an enclosure containing the suspect switch to the "OFF" position and if the switch is defective, the contacts could remain in a closed condition. Thus, the load side of the switch would remain energized despite the visual indication of the enclosure disconnect handle indicating that the switch is "OFF".

In order to remedy this condition, our supplier has indicated that you must replace the potentially defective switch or A/C disconnect switch assembly and return it to Eaton Corporation. Until the replacement switch or enclosed switch assembly is installed, you must electrically verify that the switch is not energized while in the open or "OFF" position every time the switch or enclosed switch assembly is operated. **DO NOT ASSUME THAT THE POWER IS DISCONNECTED.**

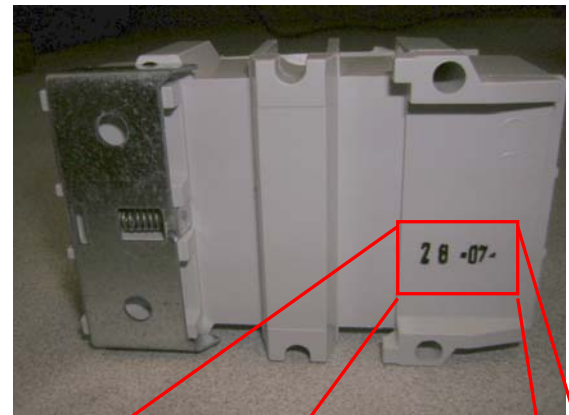
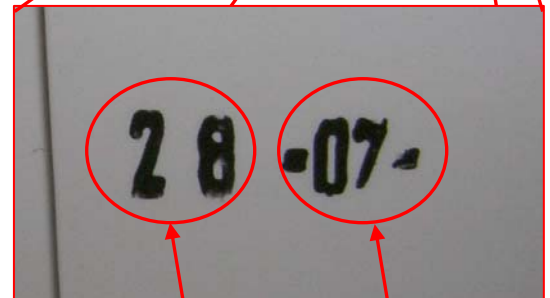
**Step 4:** If installed in and enclosure, open cover and remove the switch. The date code is listed on the bottom of the switch.

**Step 5:** If date code falls between Week 1 of 2007 and Week 50 of 2007 (01 07 and 50 07) then the unit must be replaced. If the date does not fall in the stated time period, the switch can be operated normally. The circuit can be re-energized.

***You must look at the date on the switch itself.  
The date on the switch and the carton the switch was received in may not match.***

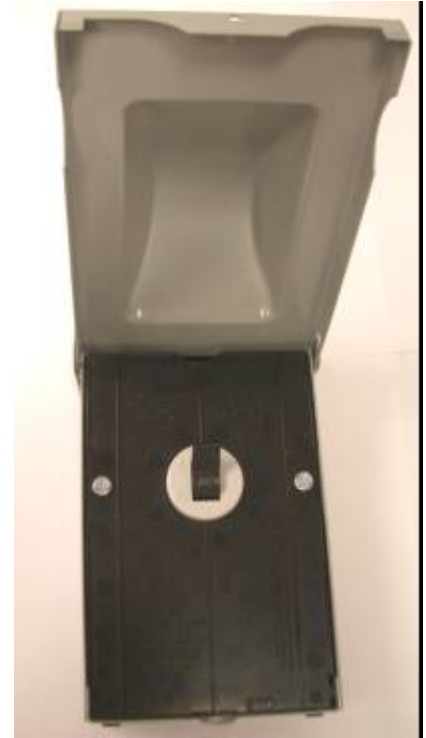
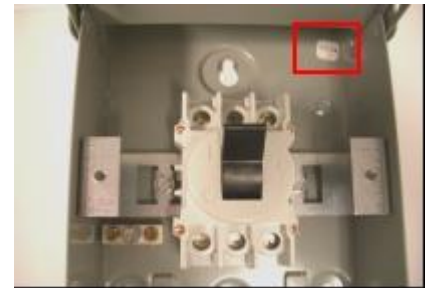
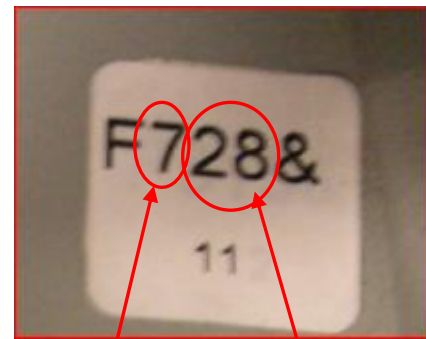
**Step 4:** The date code is listed on the upper right corner inside the case.

**Step 5:** If the A/C disconnect date code falls between Week 1 of 2007 and Week 52 of 2007 (F701& and F752&) then the date code of the switch must be checked (Continue to Step 6). If the A/C disconnect date code does not fall in the stated time period, the unit can be operated normally. The circuit can be re-energized.

**Step 6:** Remove the toggle switch using the din rail release tab mechanism located on the line side of the switch. Inspect the date code located on the back of the switch as outlined in Appendix B. If date code on the switch falls between Week 1 of 2007 and Week 50 of 2007 (1 07 and 50 07) then the switch must be replaced. The replacement switch is C362TW60. If the date does not fall in the stated time period, reinsert the switch and cover plate. The unit can be operated normally. The circuit can be re-energized.
