## Update to Important Product Safety Bulletin

### Update to Eaton/ Cutler-Hammer General Duty “B” Series Field Campaign

## **Important Product Safety Bulletin**

### **Eaton/ Cutler-Hammer General Duty “B” Series Field Campaign**

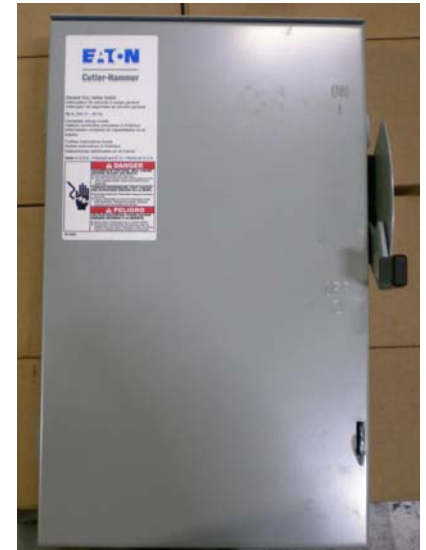
Figure 1. 60A General Duty “B” Series Safety Switch

You recently received an Important Product Safety Bulletin from Eaton Corporation regarding a recall of the General Duty “B” Series Safety Switch (Figure 1). Unfortunately, due to a typographical error, one of the affected style numbers was not included in the original table entitled “List of Affected Style Numbers”. Eaton sends this update to notify you that the **DG322NRB** has also been affected by the current field action. Additionally, if you purchased the product in the Canadian market, the style number will be preceded with the letter “C”. Please review the updated copy of the “List of Affected Style Numbers” below. Due to the seriousness of this potential issue, Eaton again asks that you return product from the list of affected style numbers (below) with a manufacturing date code between 8/11/2008 and 8/18/2008 via the process defined in the previous notification.

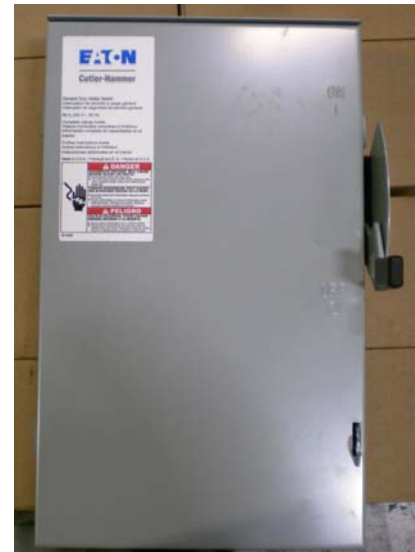
Figure 1. 60A General Duty “B” Series Safety Switch

A potential quality issue for General Duty “B” Series Safety Switches could allow the operating handle to detach from the mechanism that operates the switch. If this occurs the handle could indicate the switch is in the “OFF” position, while the internal switch is still closed.

Our records indicate that we shipped you a General Duty “B” Series Safety Switch (Figure 1) that is suspected to have a potential safety issue. The potential issue could potentially impact all General Duty “B” Series Safety Switches produced between 8/11/2008 and 8/18/2008. Please read through this bulletin and take the appropriate immediate action to effectuate repair. If you are not the end customer for this product and have subsequently shipped this product to a 3<sup>rd</sup> party, then Eaton Corporation (“Eaton”) requests that you forward this notice to the 3<sup>rd</sup> party.

There is the possibility that over time, the operating mechanism could wear in such a way that the switch will no longer function as intended, allowing the safety switch handle to indicate it is in the “OFF” position while the internal switch is still closed. This could result in a potentially unsafe condition.

In order to remedy this condition, Eaton will provide you with a replacement switch at no cost.

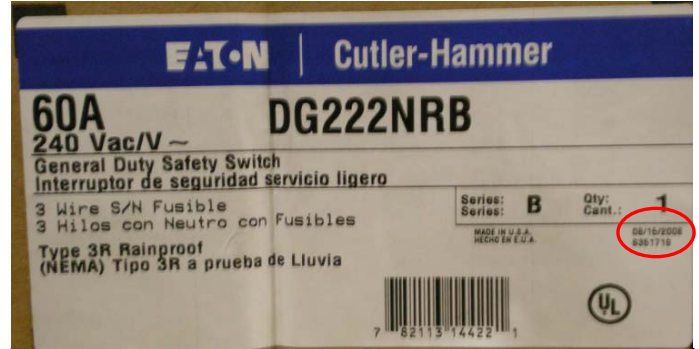
The General Duty “B” Series Safety Switches were shipped to you may have been manufactured between the date codes 8/11/2008 and 8/18/2008. The date codes for the unit or units in your possession are identified on the labels shown in Figure 2 and in Figure 3. The date code is located on both the packaging label of the box and on the inside of door of the switch. A list of affected style numbers can be found in the included table.

Figure 2. The red circles indicate where the package label date code is located.

the carton label (shown in Figure 2) or from the inside door of the unit (shown in Figure 3). If the date code is between 8/11/2008 and 8/18/2008, then you potentially have a suspect switch which Eaton will replace.

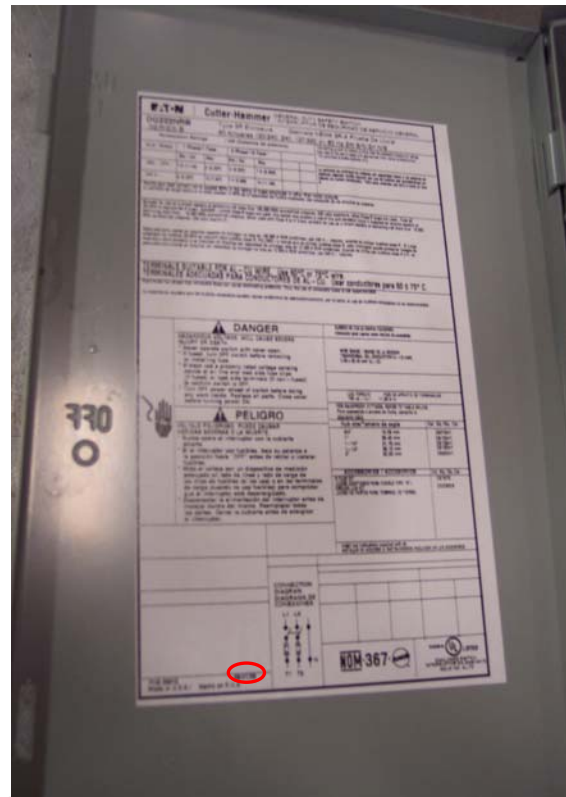
Figure 3. The red circle indicates where the date code is located on the pub inside the case of the switch
